NATIONAL PROGRAM FOR INSPECTION OF NON-FEDERAL DAMS
NEPAUG DAM (CT 00370)..(U) CORPS OF ENGINEERS WALTHAM
MA NEW ENGLAND DIV SEP 78

4. TITLE (and Subtitle) Nepaug Dam Phelps Brook Dam NATIONAL PROGRAM FOR INSPECTION OF NON-FEDERAL DAMS		5. TYPE OF REPORT & PERIOD COVERED INSPECTION REPORT

NATIONAL DAM INSPECTION PROGRAM

PHASE I INSPECTION REPORT

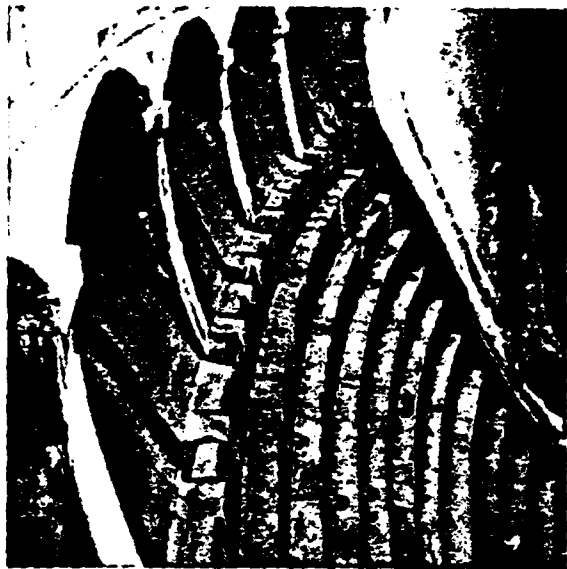
#1 Downstream side of dam and spillway in poor condition.
